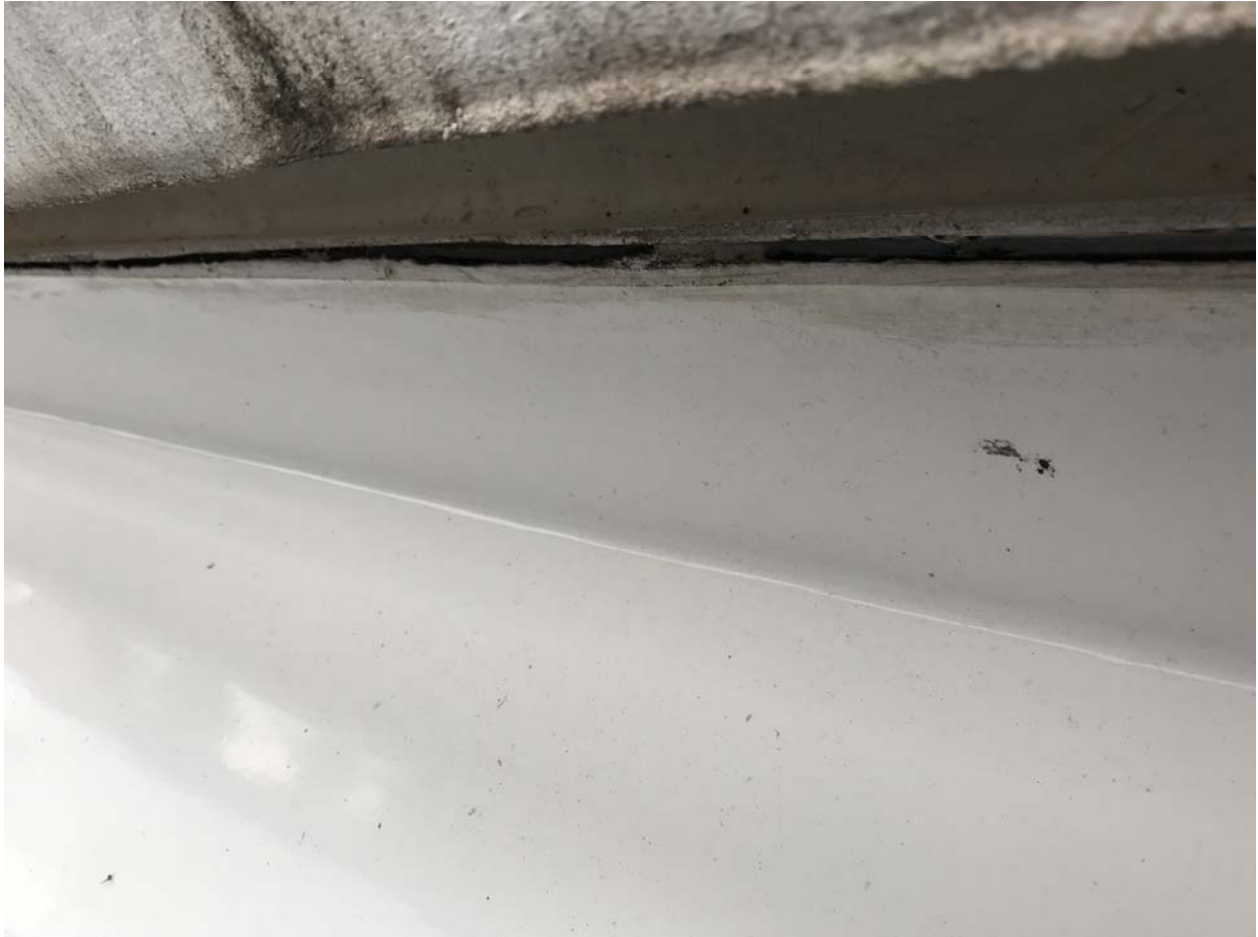
Hull-to-deck joint that appears to have pulled apart or it is a manufacturing defect and  
Needs filler sealant

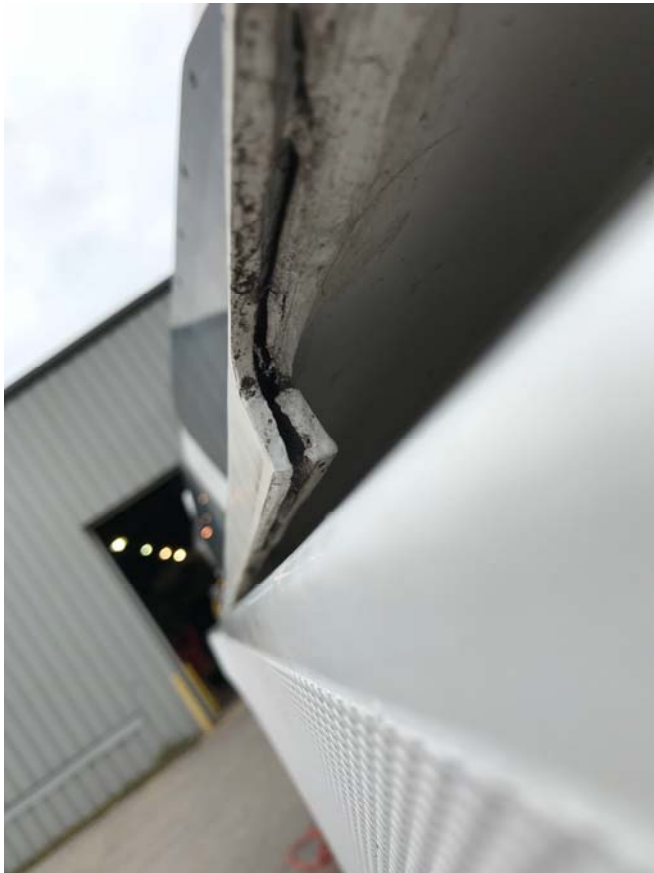
Hull-to-deck joint that appears to have pulled apart or it is a manufacturing defect and  
Needs filler sealant
